Seam Head

Brush for Seam Welding

Wheel Electrode for Seam Welding

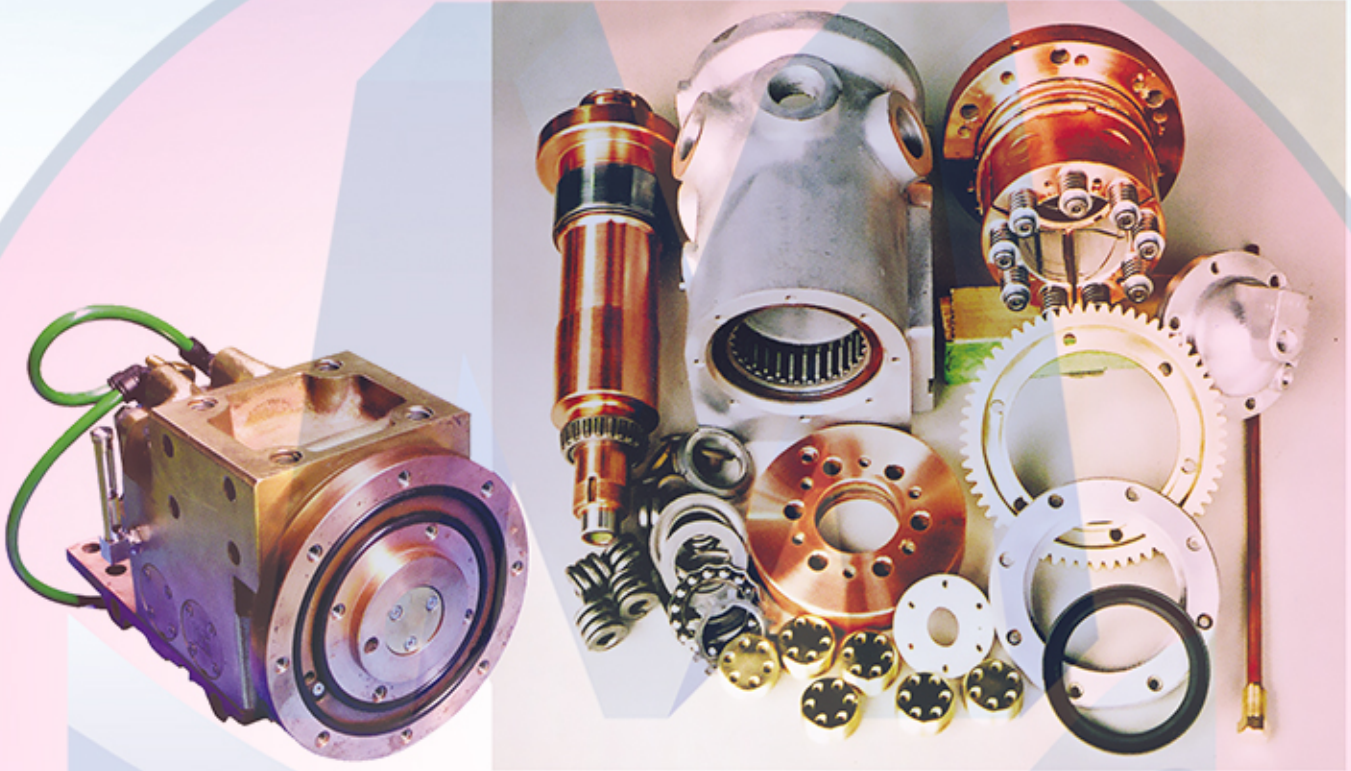
Overhaul for every manufacturer's seam head are acceptable.

1. Repair of rolling electrode shafts and current supply section of Brush.
2. Replacement of Bearings, Insulation parts and packings.
3. Replacement of Cooling water tube.
4. Adjustment of current supply section and try out.

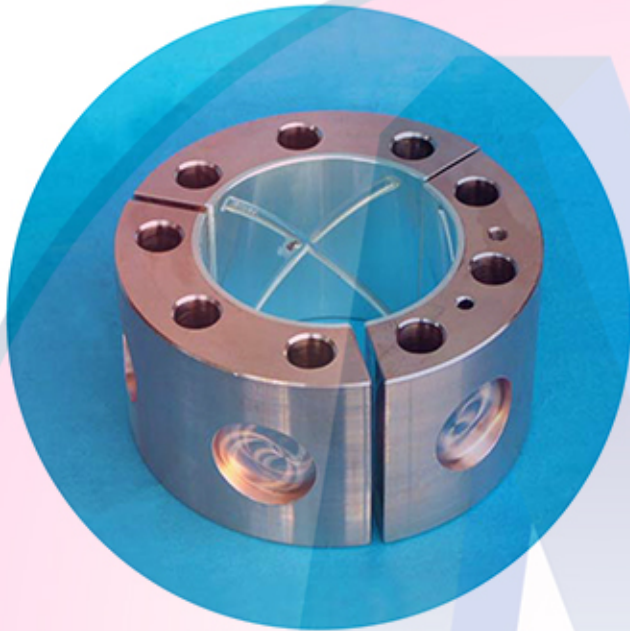
Material:Cu+Ag plate

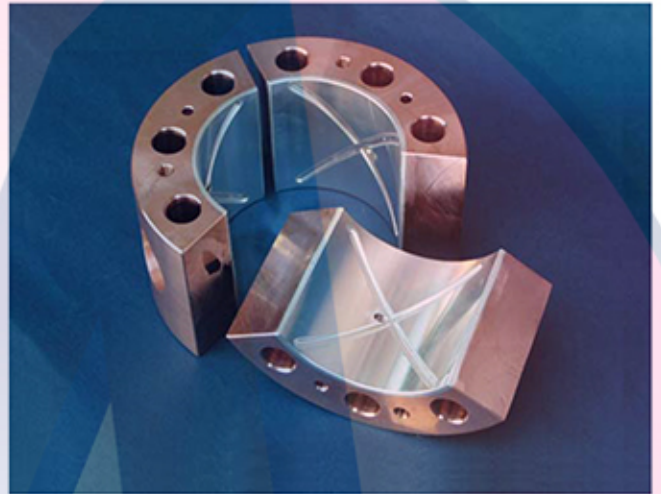
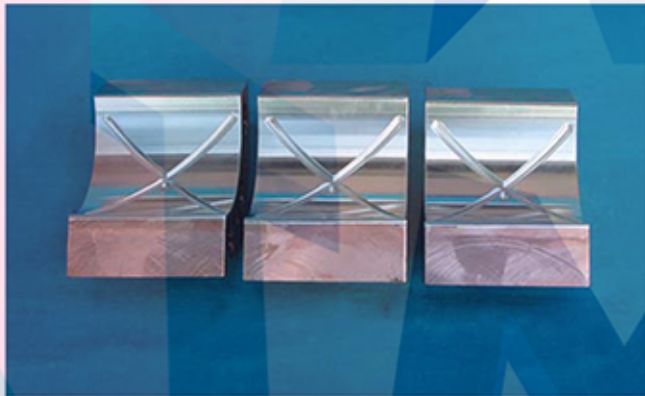
Current supply section of Brush is the section which is most deteriorated section by corrosion and abrasion.

In case of repair work by Saitama Yozai, it is sufficiently grinded after replacement of Silver plate and fully adjusted surface of grinding section.

刷子の給電面は電蝕や摩耗により劣化の激しい部分です。

埼玉溶材では修理の場合、銀板張替後の摺り合せを十分に行い、摺動部の面当たりを完全にしております。
